2. Subbasin Assessment – Water Quality Concerns and Status

2.1 Water Quality Limited Segments Identified in the Subbasin

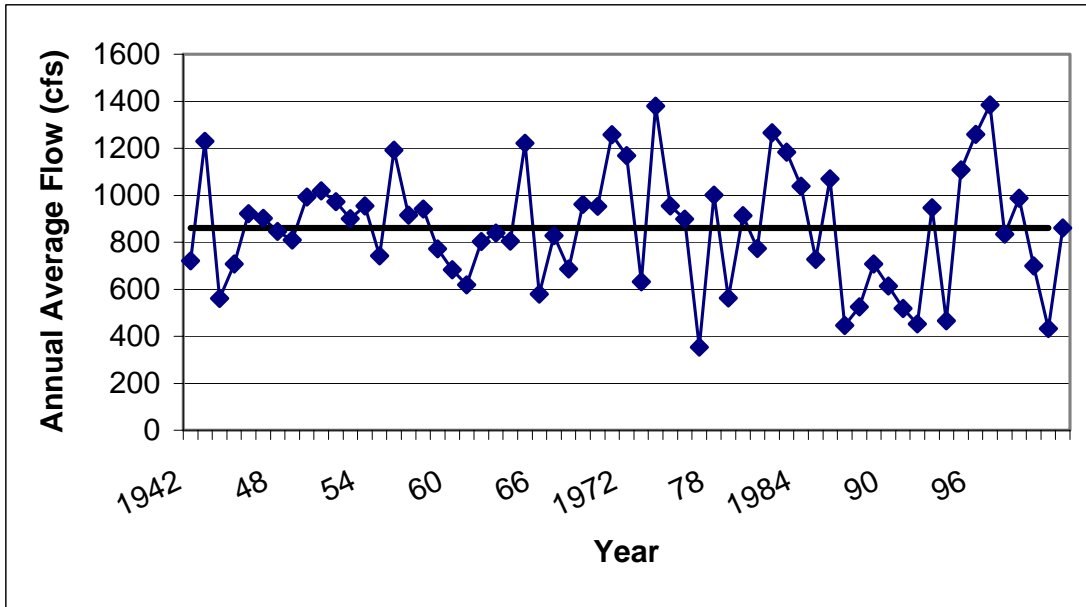
Figure 16. Annual Average Discharge at Lowman, Idaho since 1942 as Compared to Period of Record Average Discharge of 861 cfs.

Since 1942 the USGS has collected daily flow data from the South Fork Payette River at Lowman. These data provide valuable insight into the annual hydrograph for the listed segment of the river. Figure 16 shows the annual average flow at Lowman for each year since 1942. Also shown on the figure is the average flow for the period of record. This value is 861 cfs. The year 2002 is not included in this figure because data for the entire year are not yet available. The data show that the average annual flow in the river can remain relatively static for years at a time or can fluctuate dramatically from one year to the next. This relative infrequency in flow consistency makes the determination of a “typical” flow year difficult. Therefore, the average flow for the period of record is considered a typical flow for purposes of this subbasin assessment.

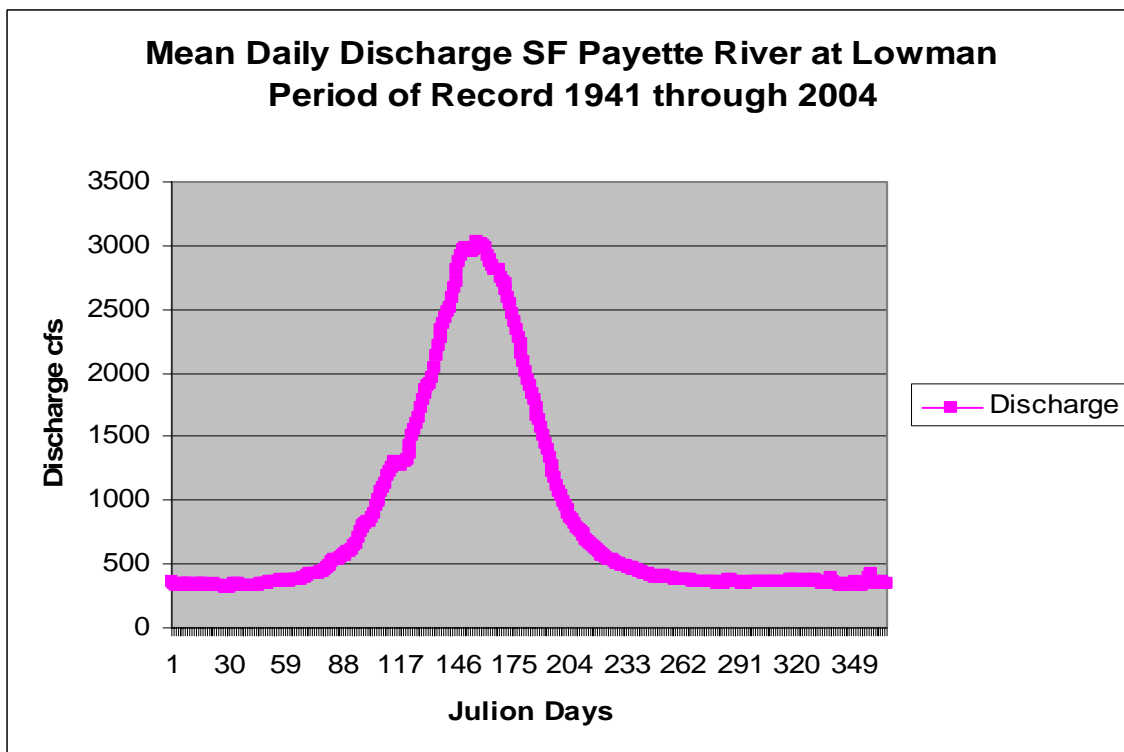
Figure 17. Mean Daily Discharge SF Payette River at Lowman, 1941 through 2004

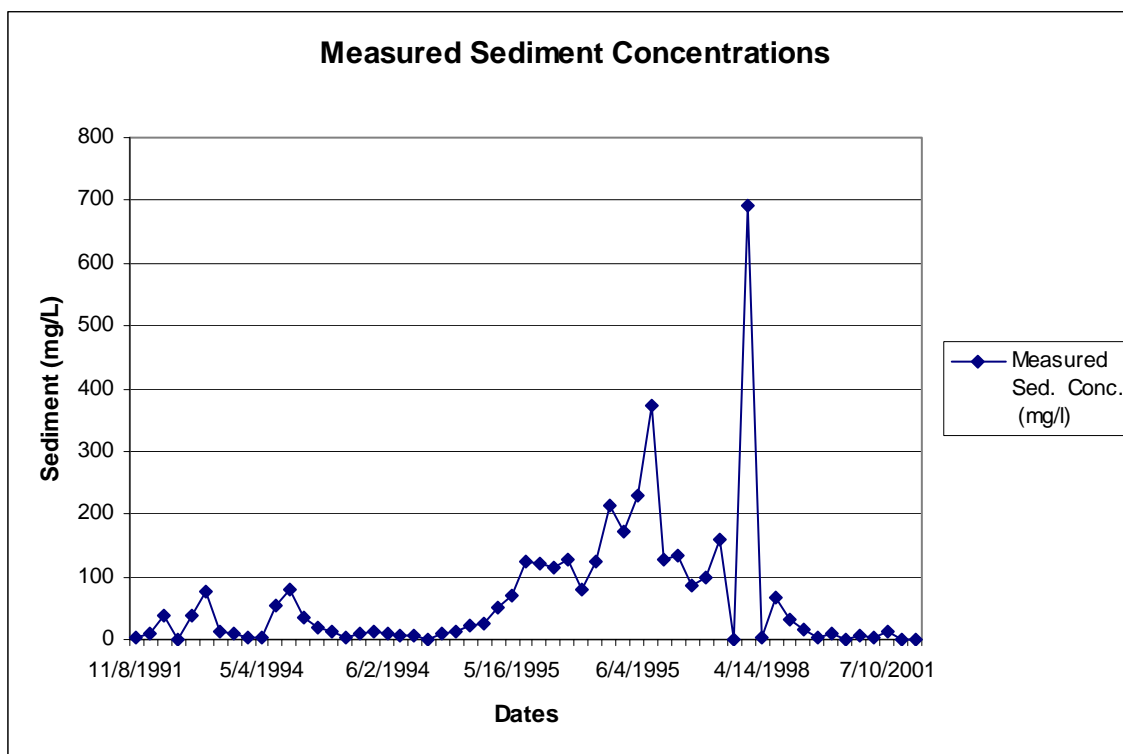
Figure 18. Measured Sediment Concentrations, 1991 through 2001

The South Fork Payette River at Lowman site is the only surface water quality station for which sufficient amounts of suspended sediment data are available. Data are primarily available during the late spring and early summer (April –June) for the years 1994 and 1995. Additional data are available in the years 1992, 1998 and 2001, but the data are far less robust. Investigators completed analyses for 85 parameters at various times during the period of record from this station. Out of these parameters, discharge (parameter code 00061) and suspended sediment concentration (parameter code 80154) best apply to an assessment of fine-grained sediment, the pollutant of concern in the South Fork Payette River.

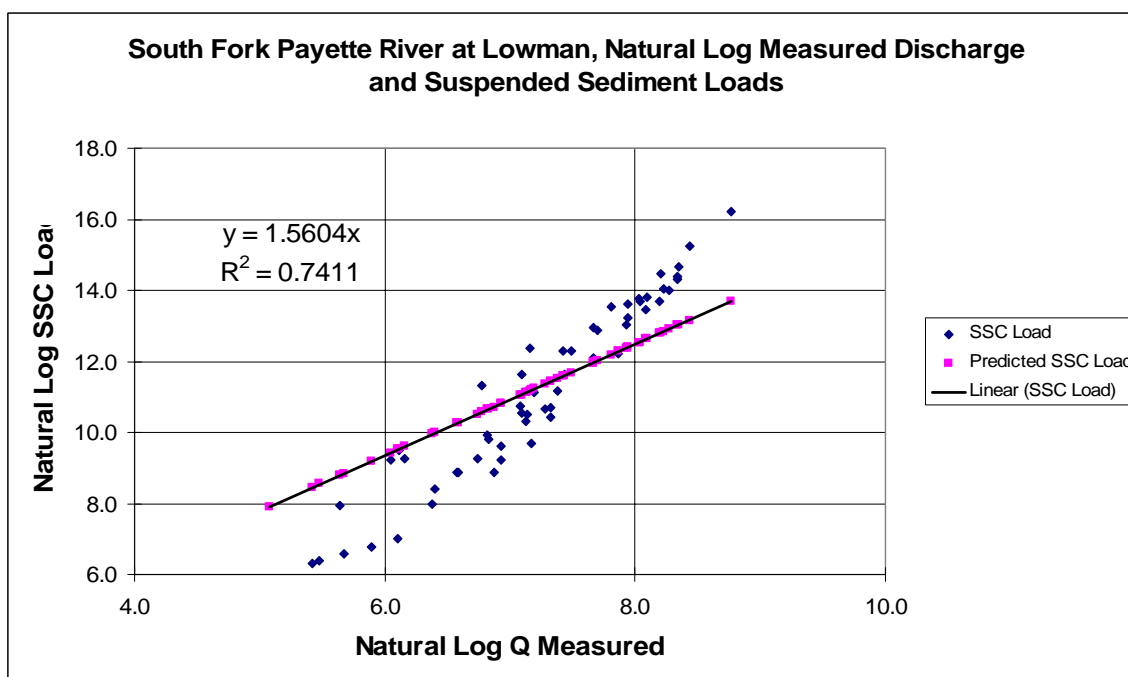
**Figure 19. South Fork Payette River at Lowman, Natural Log Suspended Sediment Load as a Function of Discharge.**

With the data available for the years shown in Table 9, a sediment rating curve was developed to evaluate year round SSC loads and concentrations based on the function of discharge. Suspended sediment data and discharge data were “normalized” into natural log values. The regression analysis for the measured SSC load and discharge are seen in Figure 19.

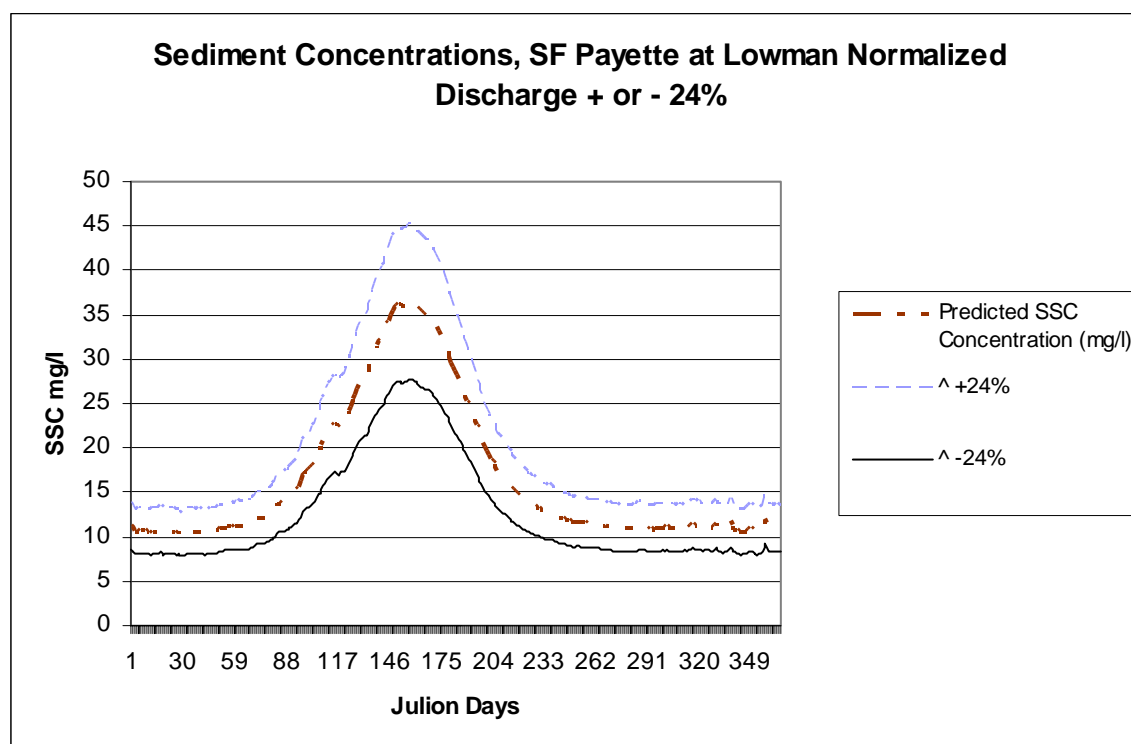
Figure 20. Sediment Concentrations, SF Payette River at Lowman Normalized Discharge + or – 24%

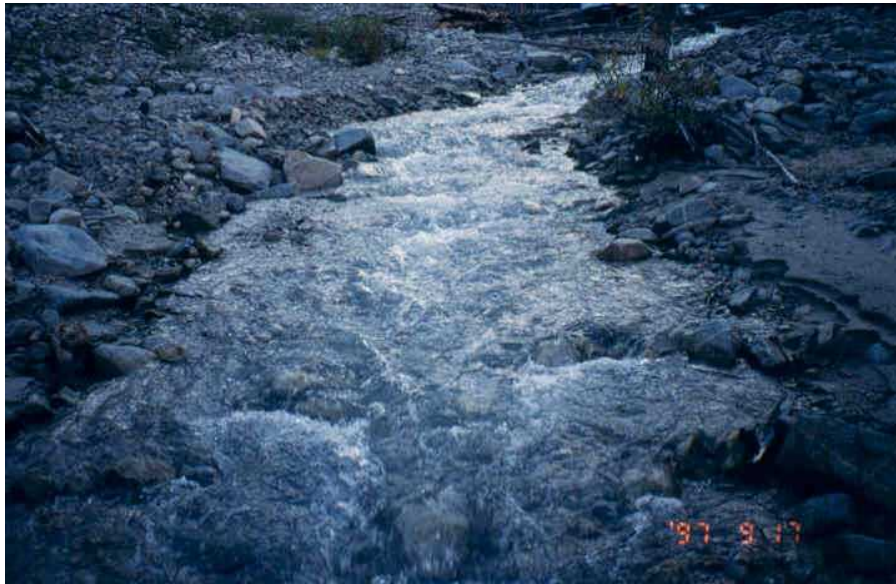
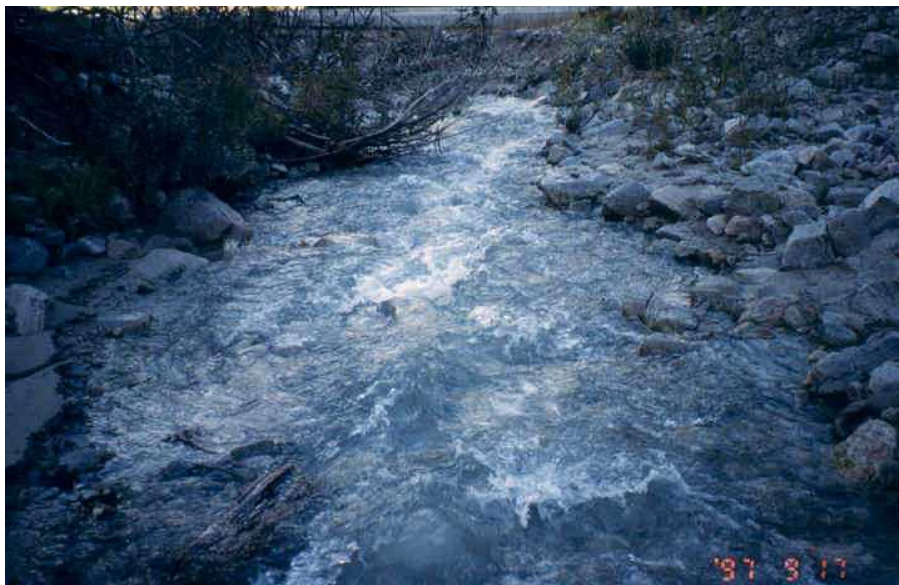
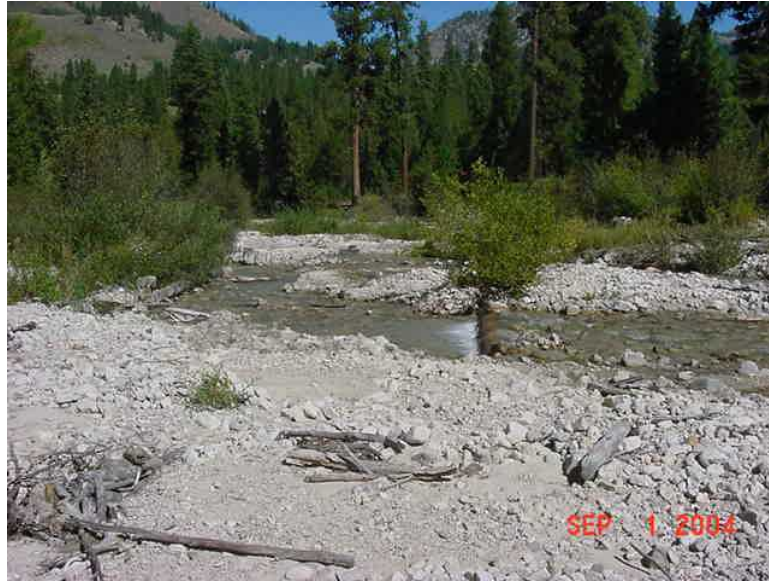
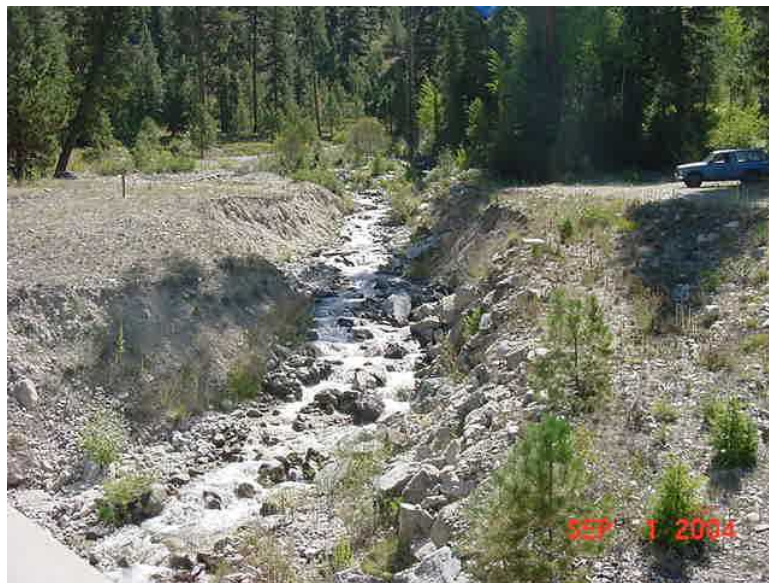
Figures 21 and 22 shows the 1997 Chapman Creek BURP site. Figures 23 and 24 show the same site in 2004. As demonstrated in the photos, Chapman Creek has been greatly influenced by hydrologic events, which resulted in the movement of large amounts of bedload sediment. It appears the riparian vegetation is improving. However, the process will be slowed by the lack of fine sediment and organic material.

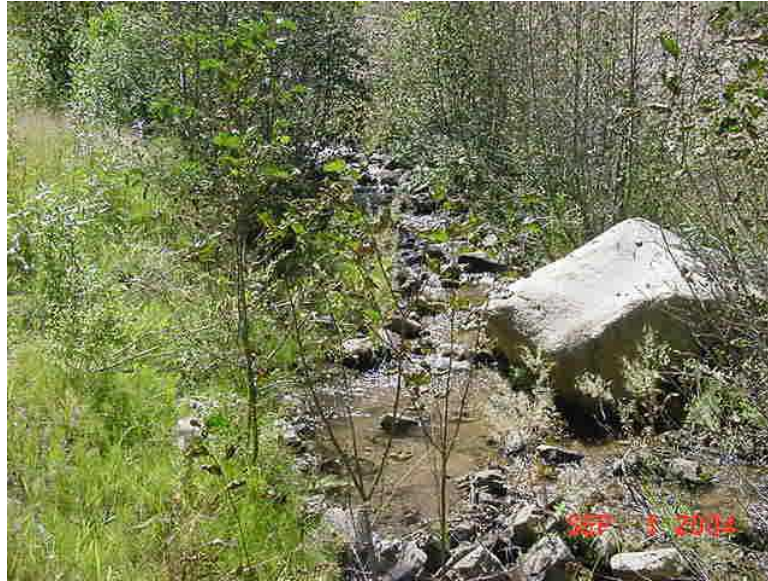
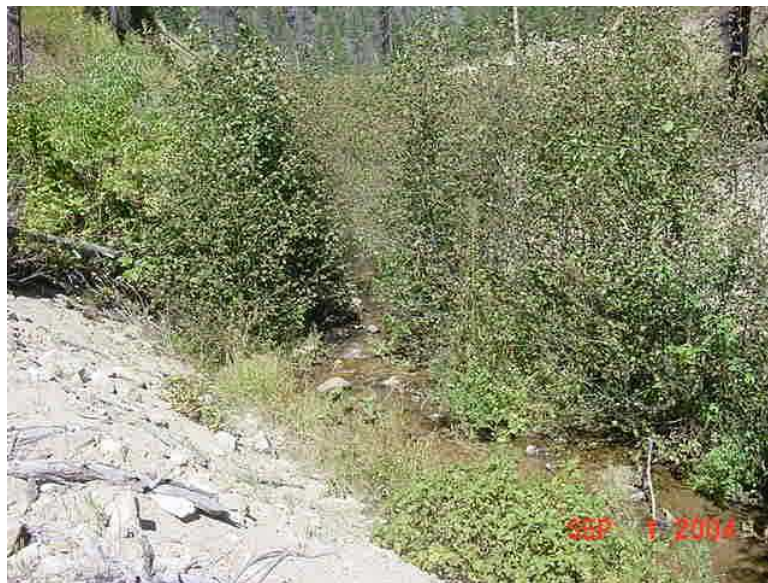
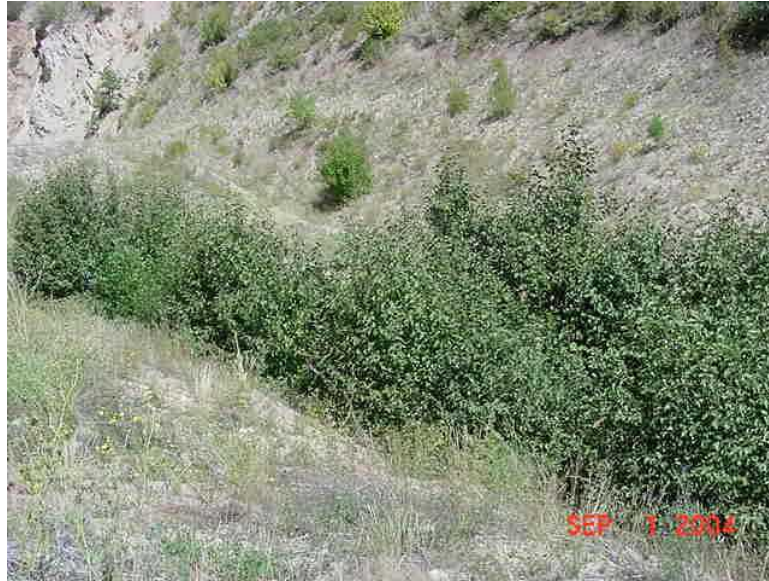
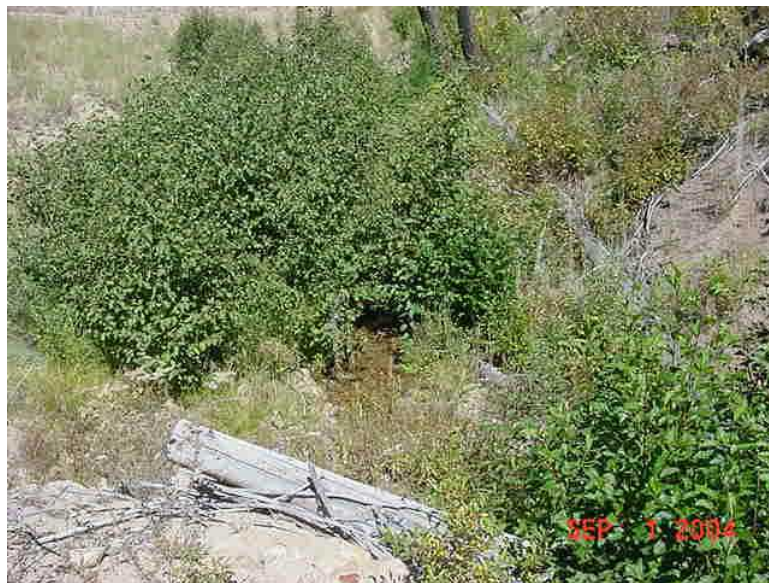
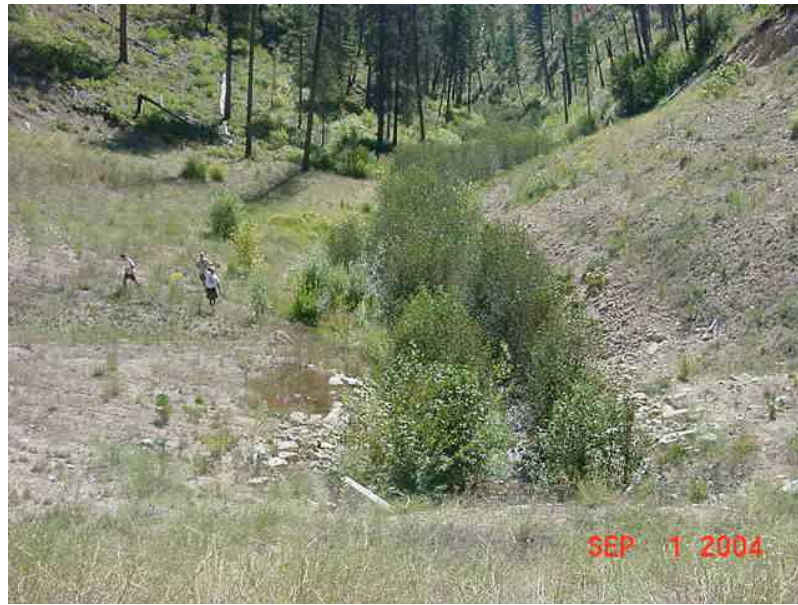
During the 1997 floods, State Highway 21 was affected with mudslides and blowouts. Figures 28 through 32 show the BURP sites in 2004. Unfortunately, photos taken in 1997 could not be located. It is suspected the 1997 rain-on-snow event overwhelmed both culverts located on Smokey Creek, causing water to back up until it spilled over the highway. This then caused the erosion of road fill on the downslope side of the highway, which led to the complete blow-out of the highway at the switchbacks. Continued head cutting upstream would have continued until a hydrologic equilibrium was reached. As evident in Figure 32,

this head cutting along with some lateral cutting directly affect the area associated with the road fill. Figure 33 shows the location of Highway 21 in the watershed.

Since 1997, Highway 21 has been reconstructed at the switchbacks associated with Smokey Creek. Metal culverts have been replaced with larger concrete structures. Additionally, metal grates have been installed over the openings of the metal culverts to prevent large debris from clogging the structures.

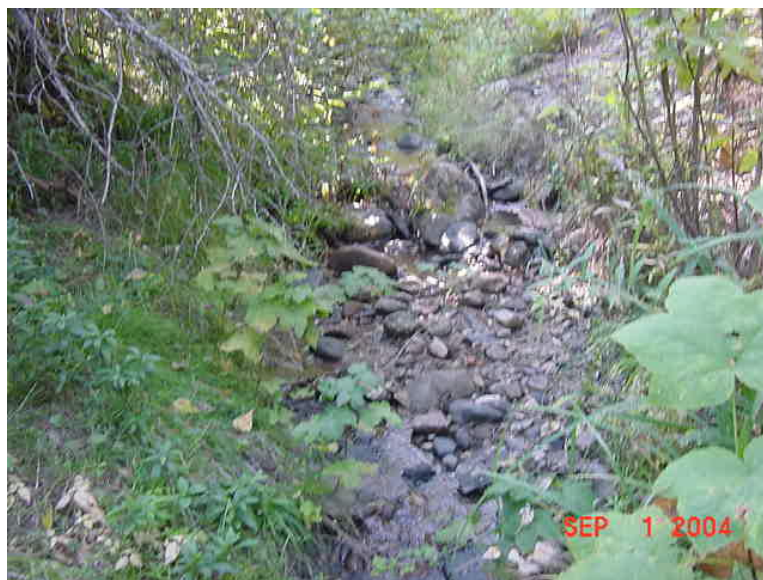
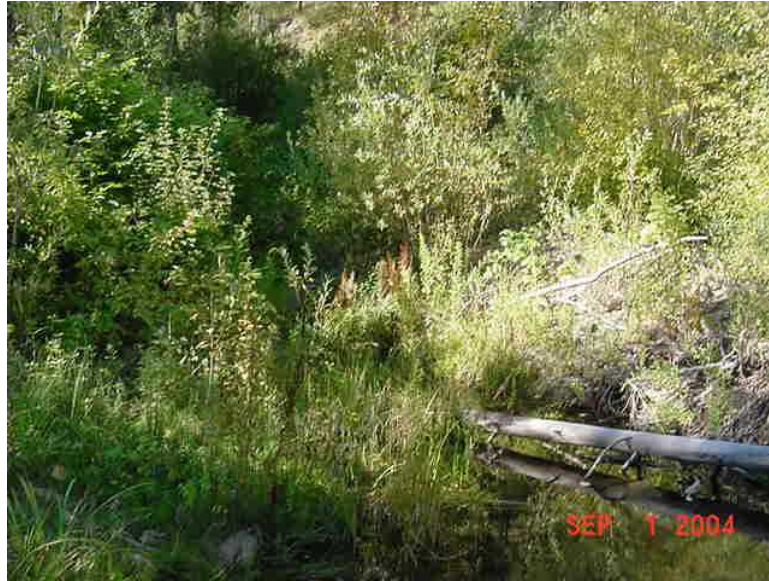
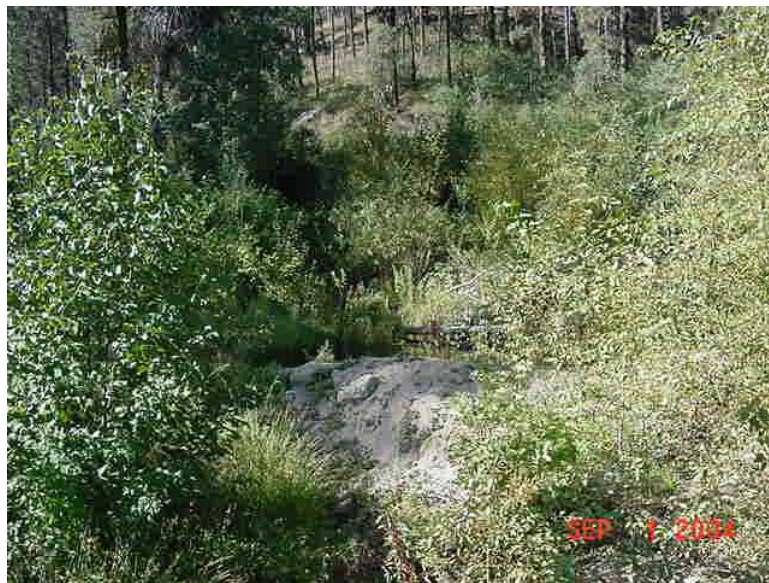
Figures 34, 35, and 36 show the current physical condition of Horn Creek. Unfortunately, photos from the 1997 BURP monitoring cannot be located. Photographs taken in 2004 show the remnants of what appears to be the movement of a large amount of sediments. The valley bottom provides no access to an adequate floodplain to disperse the energy associated with a flashflood event. These physical attributes would force high flows to scour the streambed and contribute to the movement of large amount of sediments.

The vegetation in 2004 appears be made up of mostly young alders and willows. Stream bank conditions appear stable and well vegetated with young woody species.

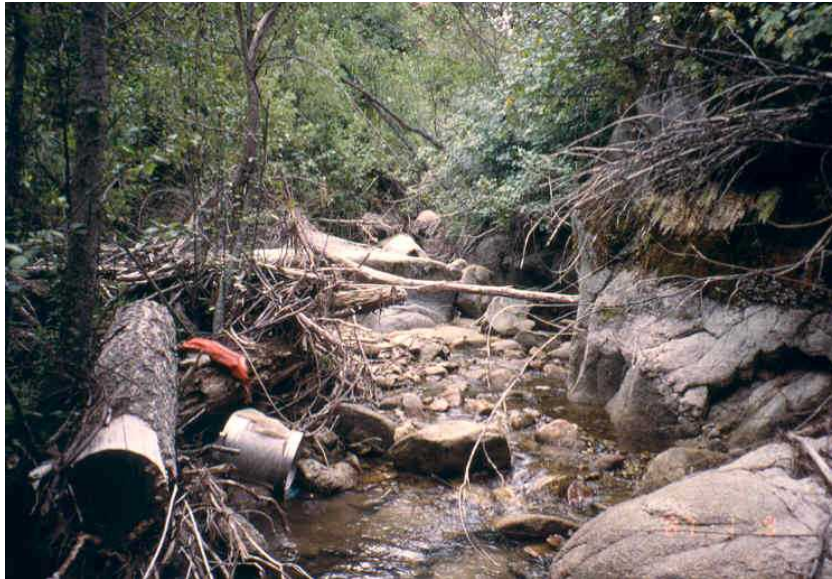
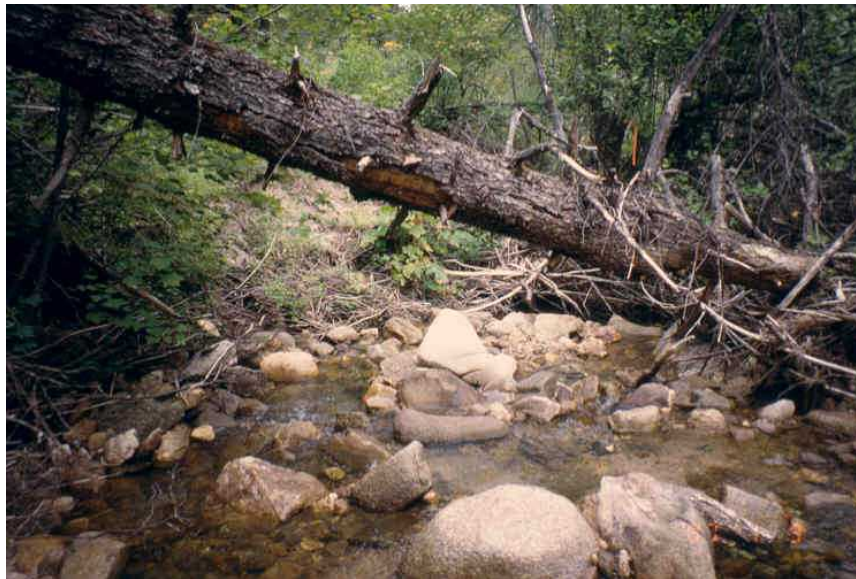
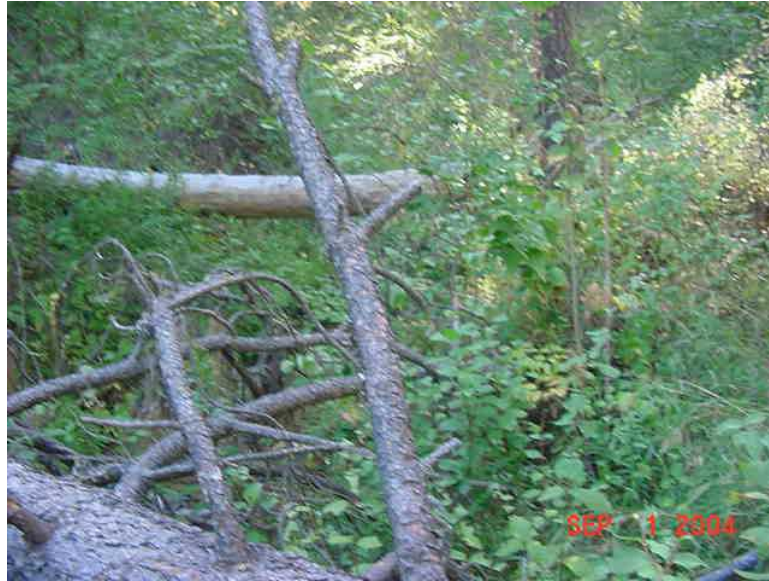
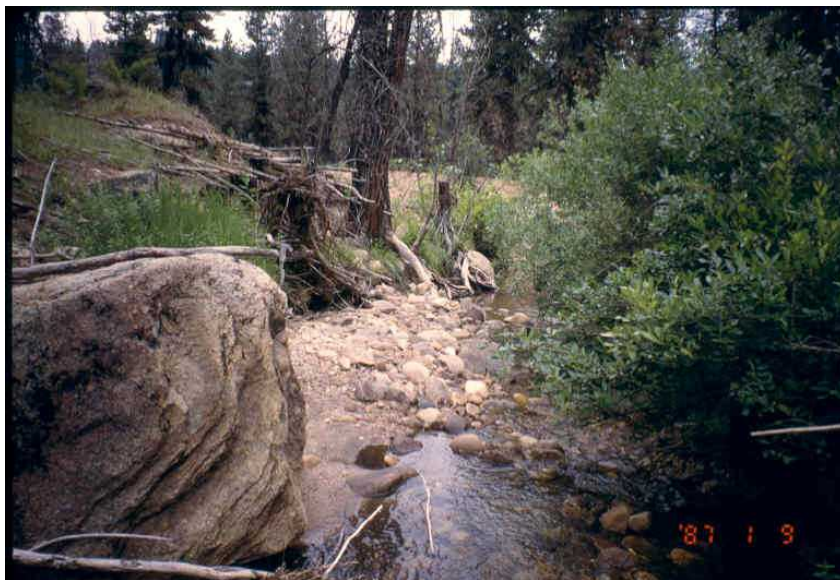
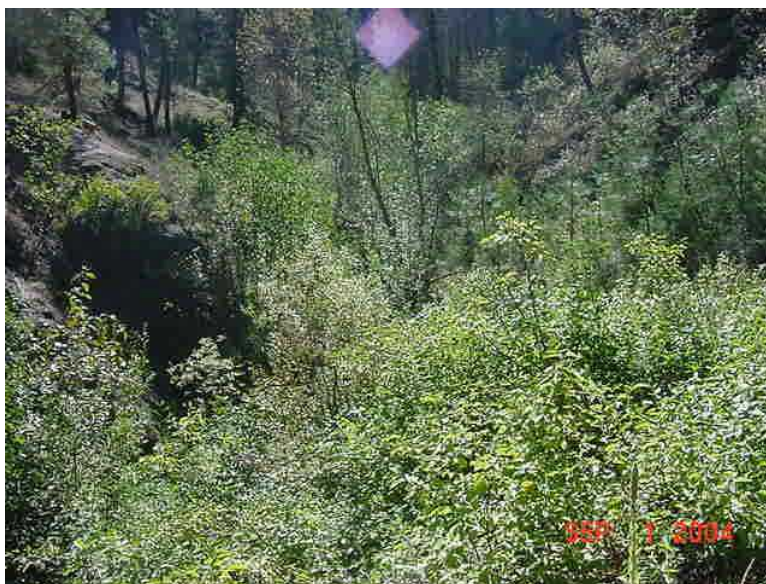
Figures 37, 38, and 40 show the physical attributes of Wash Creek in 1997. Figures 39 and 41 show Wash Creek in 2004. The valley bottom provides no access to an adequate floodplain to disperse the energy associated with a flashflood event. These physical attributes would force high flows to scour the streambed and contribute to the movement of large amount of sediments, which is evident in Figure 40.

The vegetation in 2004 appears be made up of mostly young alders and willows. Stream bank conditions appear stable and well vegetated with young woody species.
